# INCIDENT INFORMATION ON STEEL COILS CAUSING DAMAGE TO TANK TOP

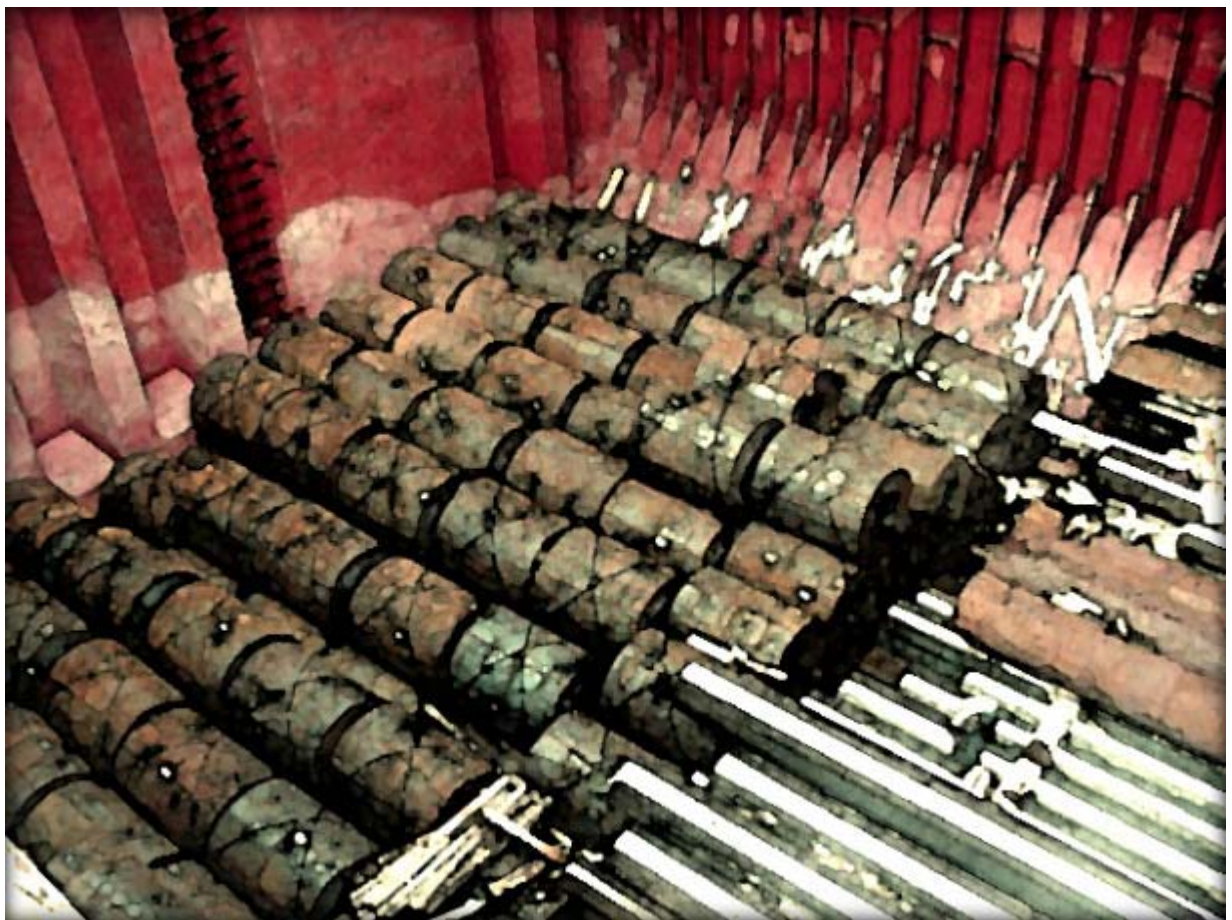
A Bulk Carrier was contracted to carry an occasional cargo of steel coils between two ports. When the vessel some time later discharged the cargo, it was noted that tank top plate had been indented. Internal inspection in the double bottom, below the cargo holds, revealed that longitudinals and floors had also been damaged.

The tank top structure had sustained damage over the whole area in the cargo holds used for steel coils. Due to the stowage arrangements made, the point loads on some longitudinals caused them to bend downwards. This in turn affected the supporting transverse girders, and especially, caused buckling in the floors (the web plates in the transverse girder), and bending of some local stiffeners.

The vessel is scheduled for repairs to maintain Class. Most probably many plates and stiffeners in the transverse girders will need to be cut out and replaced, together with some of the affected longitudinals.

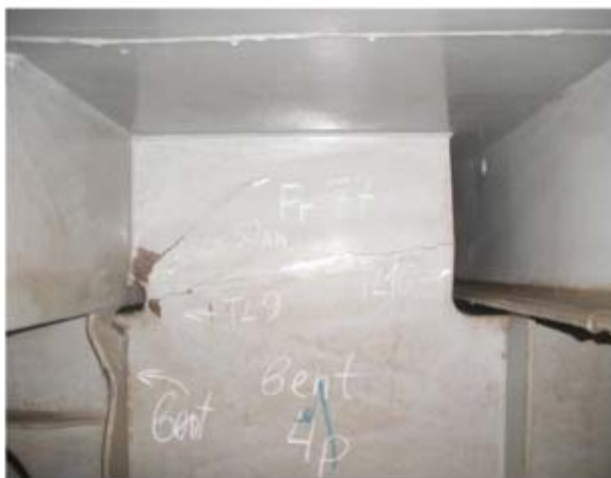
For the vessel with the damaged tank top, steel coil loading instructions were not available, and neither were hull local strength calculations made beforehand, for this specific cargo. It is suggested that the maximum cargo weight of steel coils has most probably been concluded from the maximum allowed evenly distributed load of the hold. However, as the degree of damage clearly demonstrates, this was not the best assumption for steel coils. The reason is that the coils have probably been resting on every second longitudinal only.

*Photo above to the left: A picture taken under the tank top showing buckling of the floor (web plate) and a bent local stiffener. The longitudinal to the left has been severely overloaded while the longitudinal to the right looks almost unaffected*

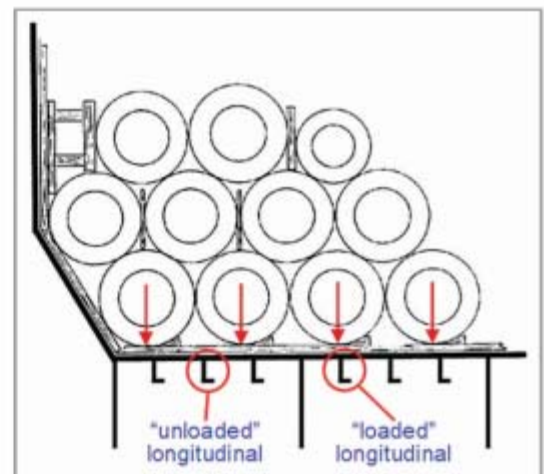
*Image above to the right: Illustration of a typical loading situation of steel coils, showing how the point loads from the steel coils will affect some longitudinals more than others*

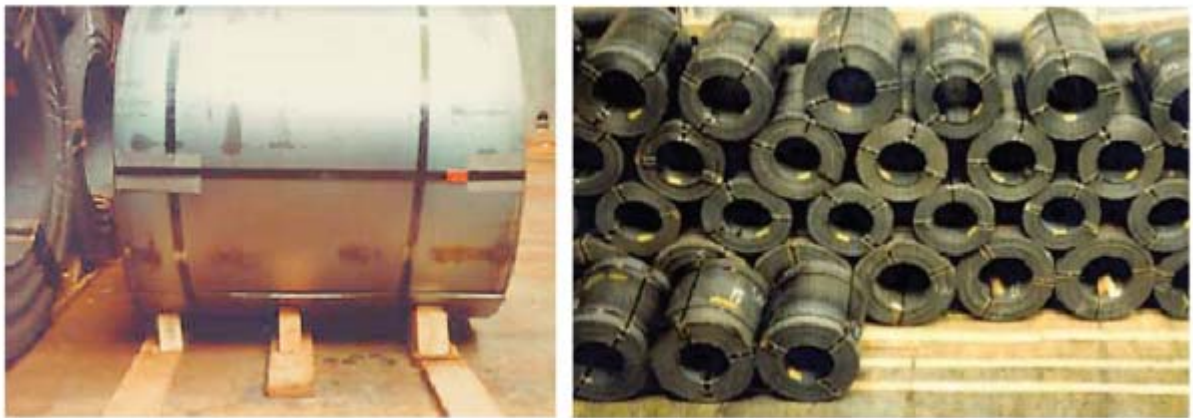
enough to distribute the load to the next longitudinal, not positioned immediately under the steel coil. The photo below to the left, shows typical dunnage with thin pieces of wood. If this dunnage was increased in thickness to say 500 mm or combined with some strong steel H-beams, the load on the tank top could be considered as an evenly distributed load. To use five pieces of dunnage instead of three has very little effect as long as the dunnage wood remains thin (except of course for the point loads on the same longitudinal for very wide coils).

*Photo above to the left: Photo illustration of steel coil on thin pieces of wood*
